DEVELOPMENT OF AN IDEAL AND REPLICABLE WATERSHED FOR RAINFED RICE PRODUCTION SYSTEM IN EASTERN INDIA

Water Technology Centre for Eastern Region

2004

Research Bulletin
(NATP-RRPS-17)

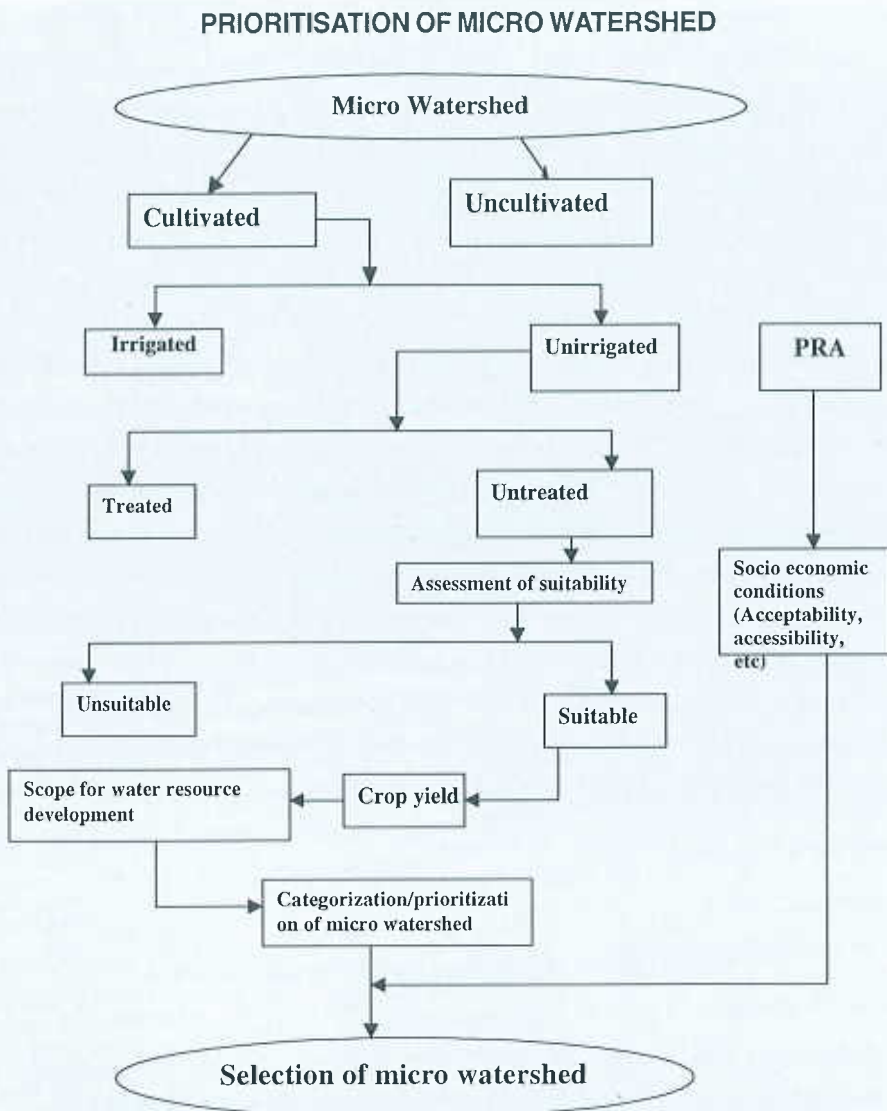
Fig. 2. Flow chart for preliminary prioritisation of micro watershed.

1. Cultivated area > 25%
2. Irrigated area < 25%
3. Treatment percentage < 25%
4. Soil suitability >25%
5. Paddy crop yield < 50% of average
6. Scope for water resource development > 50% area for life saving irrigation
7. High cooperation by farmer is to be assessed through PRA study.

The above prioritization technique is presented in the form of a flow chart, which is given in Figure 2. However again ranking technique was used to further refine the above methodology. By putting weights and ranks to development criteria which comes from different watershed characteristics like crop factor, soil, management factors, and socio economic conditions, the priority index was calculated for each of the factor and then cumulative priority index was obtained. It was further tested through PRA technique to come to the final selection. The next preferred prioritization technique evolved from this study is presented in Figure 3.

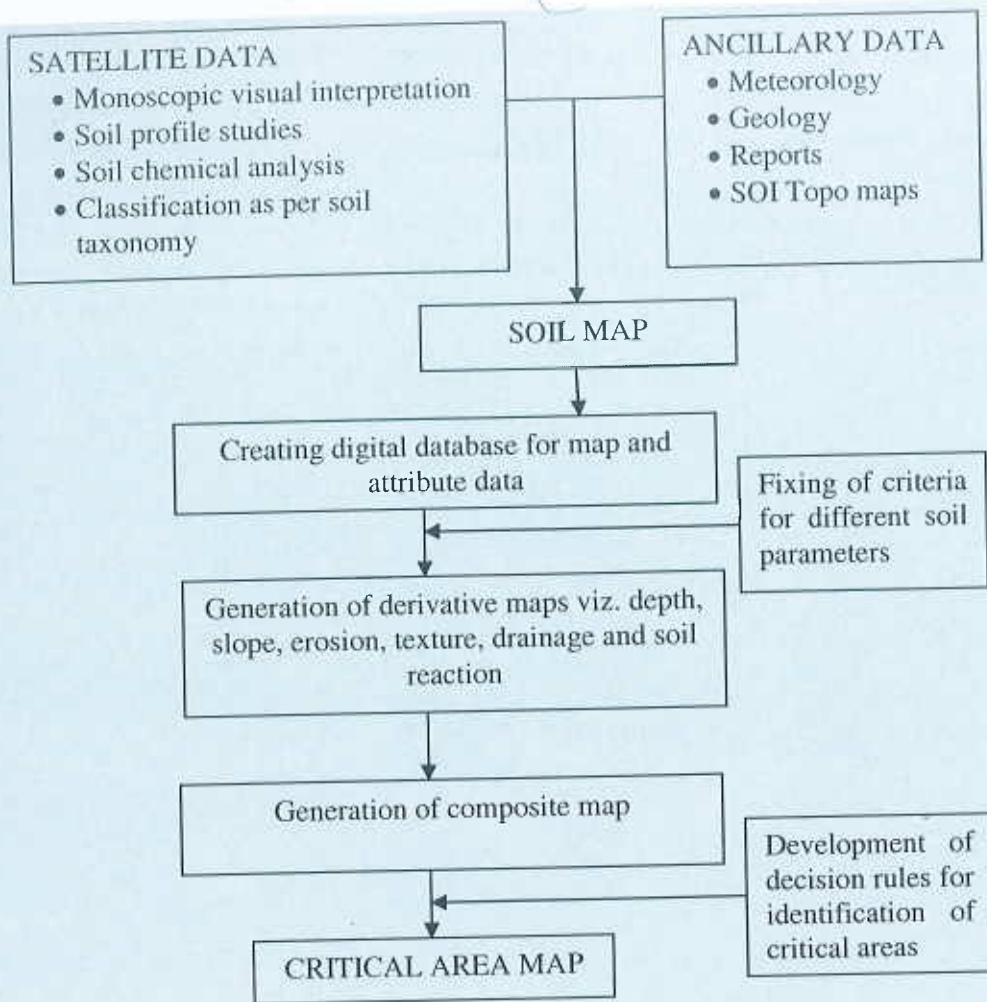
Fig. 4. Micro watershed prioritization methodologies using satellite and ancillary data.

Derivative thematic maps viz, soil depth, soil texture, internal drainage; slope erosion and soil reaction were generated and combined to develop a composite map. Rules were framed for identification of critical areas (a critical area is the one which is having more than one soil/ site limitation). Composite map was converted to critical area map. The methodologies based on soil parameters and different thematic layers obtained from remote sensing satellite images were utilized for prioritization of micro watershed, which is present in the form of a flow chart in Figure 4.

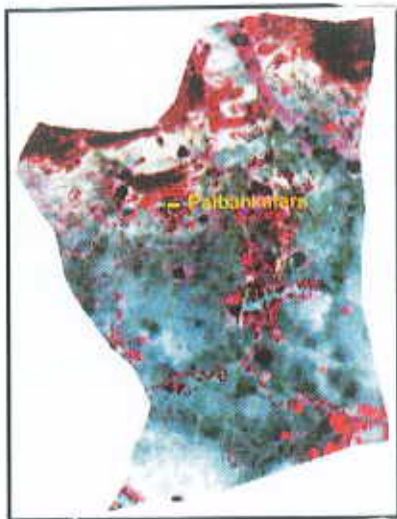
Fig. 7. IRC-IC FCC (PAN + LISS - III) of micro-watershed (path : 105, row : 058, date of pass : 5.4.2000).

Figure 7 and the action plan map for Nagaria nala watershed is given in Figure 8. The different actions/ measures recommended for rainfed rice production systems of the micro watershed area are:

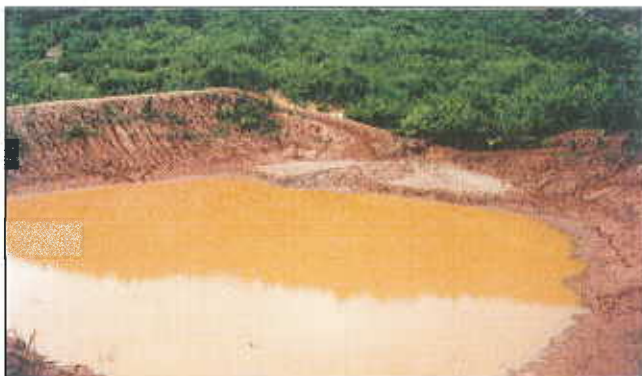
Plate 1. Percolation tank near Jamupatna village.

A percolation tank was constructed at the food hill near Jamupatana village. An emergency spillway was provided for safe disposal of excess runoff. The photograph of the percolation tank is given in plate 1. The design dimensions of the percolation tank is that, the length of tank at the top is 32 m, length of tank at the bottom is 23 m, the width of the tank at the top is 29 m and that at the bottom is 20 m. The depth of the percolation tank is around 3 m. The capacity of the structure is 2784 cubic meter. The cost is Rs. 48,000 only. The water level varies from 2.1 m in July to 1.1 m in December.

Accumulation of water level in percolation tank started during last week of June and maintained its peak in the month of October, thereafter declined and become dry in 1st week of March.

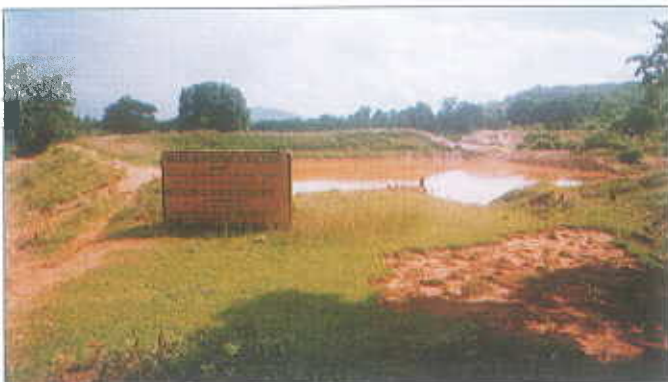
Plate 2. Water Harvesting tank near Paikbanakatara village

One water harvesting structure (WHS) was constructed in Paikabankatara village in the slope of degraded forest. The catchment area is 20.5 ha. Runoff from another small channel is diverted to the structure by constructing an embankment adjacent to WHS. The length of 3 m high guiding embankment is 10 m. The length of the tank at the top and bottom are 41.12 m and 31.88 m respectively. Width of the tank at the top as well as at the bottom are 29 m and 22.88 m respectively. The depth of the WHS is around 3 m. A spillway of suitable dimension is provided to safely dispose of the excess runoff water from the tank. The photograph of the water harvesting structure is shown in plate 2. The capacity of the structure is 3567 cubic meter. But water stored during monsoon due to embankment cum WHS is 5233 cubic meter. Approximate estimate of runoff diverted during monsoon over the spillway is 1254 cubic meter. The water level in the WHS varies from 3 m in August to 0.6 m in May. The weekly water level fluctuation of both WHS and percolation tank is given in Table 5.

During the last week of June 2003 the rainwater started accumulating in WHS. Thereafter it increased upto 3.00 m depth towards end of August. Since the rainfall in September was less as compared to August the water level slightly decreased and it went upto peak (3.10m) during October. Afterwards it started declining upto end of

January 2004 (2.20m). Because of rainfall during 1st week of February the water level slightly increased upto 2.30 m and it again went down to only 0.80m during 3rd week of April. Since there was a rainfall of 56 mm during last week of April, the water in WHS maintained its level allowing the evaporation loss and then it decreased to dryness at the end of May. The silt depositions in two loose boulder check dam at the inlet of WHS were 3.91m³ and 2.40m³ respectively.

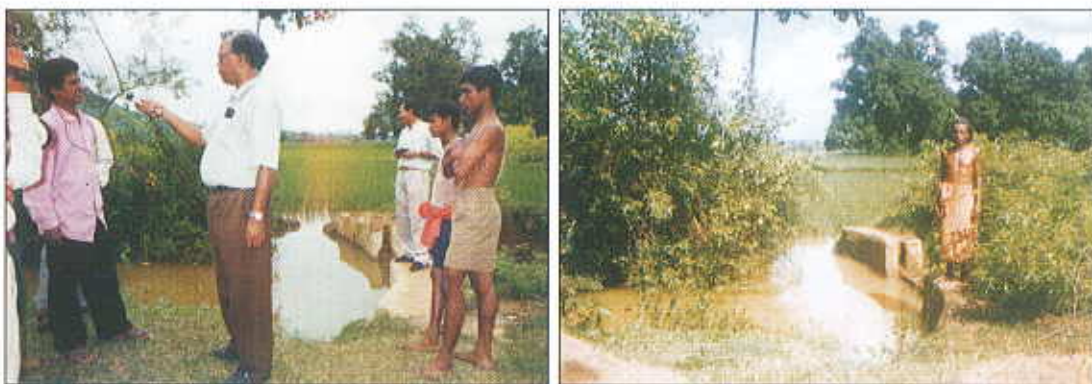
Plate 3. Masonry check dam at Kurumbankatara ashram

Permanent masonry structure has good impact. During *kharif* 2003, 10 ha of paddy has been irrigated during drought time (supplementary irrigation) in eastern side and 5 ha in the western side. Also during *rabi* 15 ha of pulses and 1 ha of sunflower have been irrigated by the structure. The water level in the nearby well (Kurumbakatara Ashram) has been increased from 3.2 m below ground level to 2.9 m during the month of April. Since it was done on participatory basis, user group have removed silt on the upstream of check dam by themselves, to the tune of 10 to 15m³.

Earthen check dams reduced the velocity of runoff and allowed to percolate but its life was very short. Out of 10 check dams during 2003 monsoon 3 dams were breached and 7 dams are still working well. This has decreased the siltation of the WHS. Silt deposit in each check dam after monsoon month varied from 6 to 8 m³. Loose boulder structure has similar impact like earthen check structure. But all ten structures are in good condition after the 2003 monsoon. Silt deposit also varied from 10 to 12 m³ in each structure.

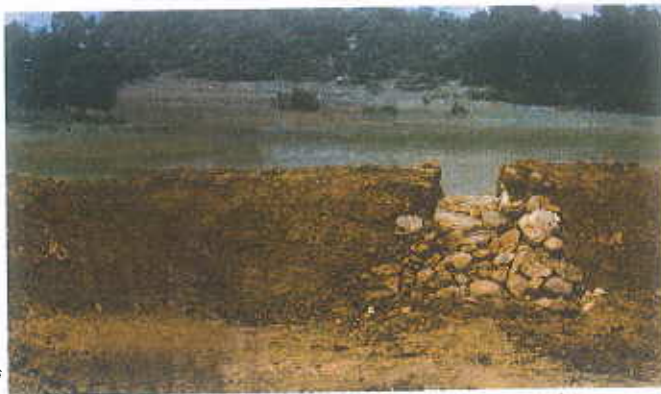
Plate 4. Contour bunding with spillway.

A contour bund cum trench of 100 m length was constructed on the sloping degraded land of Paikabankatara village to conserve water and arrest the silt materials above it so as to develop a good fertile land. Dimension of contour bund/trench is as follows. Height is 0.7 m, top width is 0.5 m and bottom width is 3 m. Three overflow spillways have been provided on the bund to dispose off the excess water to keep the bund safe against hydraulic failure.

The constructed contour bund along with the surplus weir is presented in plate 4. As per the advice of Scientific Advisory Panel (SAP) members, in the up steam of this contour bund near the foot hill, all the ten plots were bunded along contour with contour trench. Soil erosion has been reduced to a greater extent. In one season, the trench was filled with silt (width 0.5 m and depth 0.7 m).

The runoff from the hillock has been reduced. Erosion of topsoil has been reduced. Before construction, soil pit was dug for soil strata identification from 0-90 cm in 6 batches. It was seen that there was no soil in top layer except fractured stone pebbles. But after construction of contour bund, it was found that soil structure has been improved in the 30 ha degraded area near hillock. That is why farmers have gone for black gram in the entire area during *kharif* 2002 and *kharif* 2003. The yield of black gram was 3 to 4 q/ha.

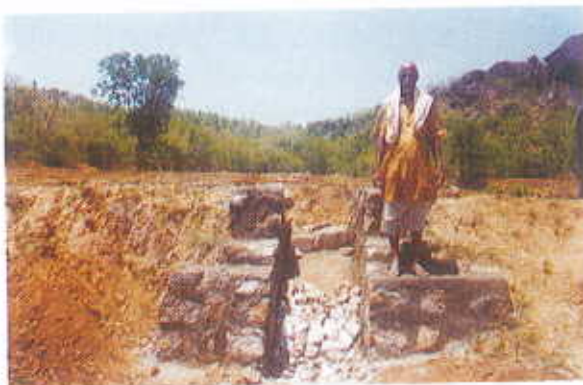
Plate 5. Land modification with stone masonry spillway.

Near the hillocks of Paikabankatara in the western side, terraced lands have been degraded due to high velocity runoff, soil loss and gully formation. The total area suffered from this malady was around 6 to 7 ha. The bunds were strengthened with stone masonry spill way in each plot on participatory basis (Plate 5). Such stone masonry spillway was constructed in five places with bund strengthening. The total cost of the structure was Rs. 9000 and out of that the farmer's share was 60%.

This was constructed during April 2004. On the 1st pre monsoon shower of May, it was seen that excess water has been smoothly diverted from one terrace to other terrace. The slope is 4%. No gully formation is there. Seeing this another group of 8 farmer's have come forward to construct similar work. *Kharif* productivity of 2004 was increased with less damage to crop.

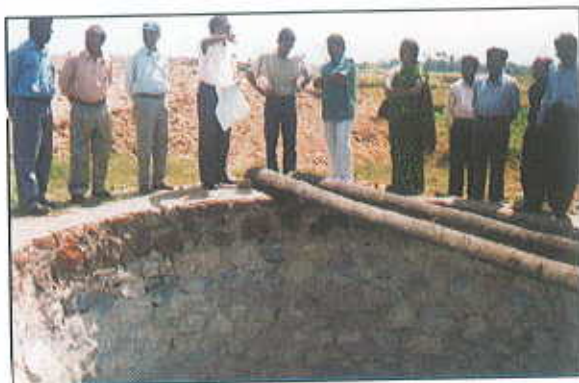
Plate 6. Dug well near Kurumbankatara road.

Two number of open dug wells were constructed on participatory basis in the valley line as per action plan. One well is located near Nagari nala (5 m away from nala and 100 m away from WHS) at Kurumbankatara village. The diameter and depth of one open dug well is 4.65m and 6.43 m respectively and that of the other well diameter is 4.63 m and 6.60 m

respectively. The second dug well is a little away (500 m) from valley line as the water user group around second dug well are cooperative and technology receptive farmers (Plate 6). In each case 5 to 6% share has been contributed by water user group.

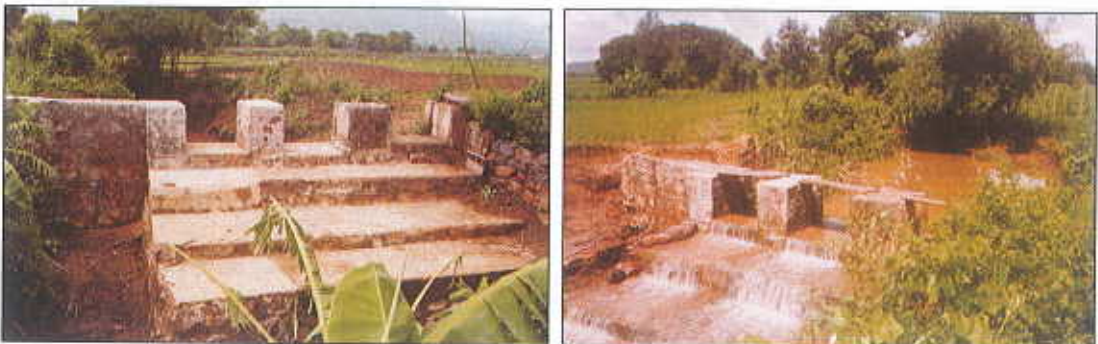
Plate 8. Diversion weir on Nagarina.

As per the action plan, people's response, SAP member's advice and PI's concurrence, a diversion weir was constructed on participatory basis in Nagari nala at Kurumbankatara village (Plate 8). The total member of farmers in this diversion water user group was 35. The design of the weir was based on hydraulic, structural and hydrological considerations. During monsoon, peak flow was recorded after heavy storm at a designated point with regular geometrical surface. It was also calculated by curve number technique. The spill way was designed for 0.2 cumec and had 3 openings. The spillway dimension was 0.5 m x 1.9 m. The

length of diversion weir was 11 m and bottom width was 4.6m, height of structure was 3.9 m and spillway height was 2.0 m. There were two spillways, one on left side and one on right side. The total cost of the structure was Rs. 32,000 and the user group's share was 55% and the project share was 45%. The entire construction was carried out and supervised by water user's group.

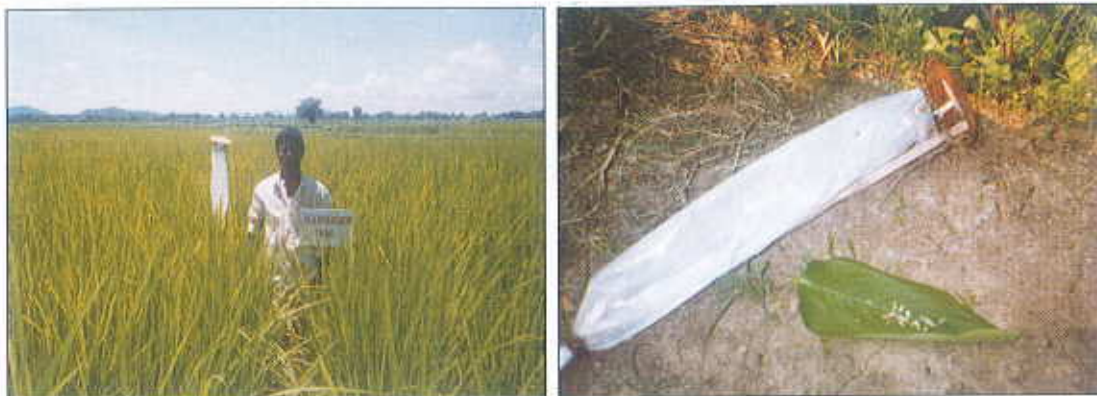
Plate 17. Integrated pest management using Pheromone trap.

Integrated pest management has been taken in the farmers' field. Sex-pheromen trial has been taken to trap the insect/ pest. A sex-pheromen trap installed in farmer's field is shown in the plate 17. This trial showed that a majority of the insects were trapped in the pheromen trap and thus pest management could be done without any adverse impact to environment.

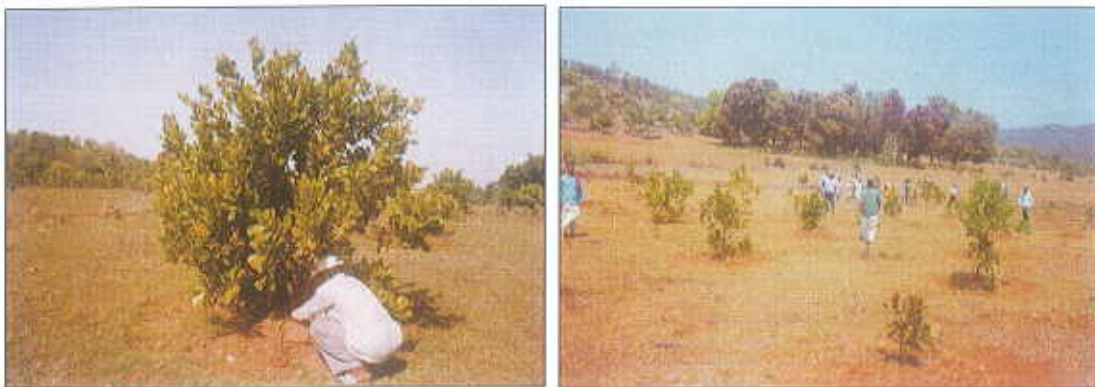
Plate 18. Cashew nut plantation in a degraded land.

The farmers had made heaps near the root and rings of 0.5 m radius around the cashew nut plant for in-situ soil moisture conservation. Also for control of leaf curl disease and tikka disease of cashew nut spraying of insecticide like chlorophyriphos was done. Anti-termite treatment was taken before planting of cashew nut and teak. The photograph of cashew nut plantation is given in Plate 18.

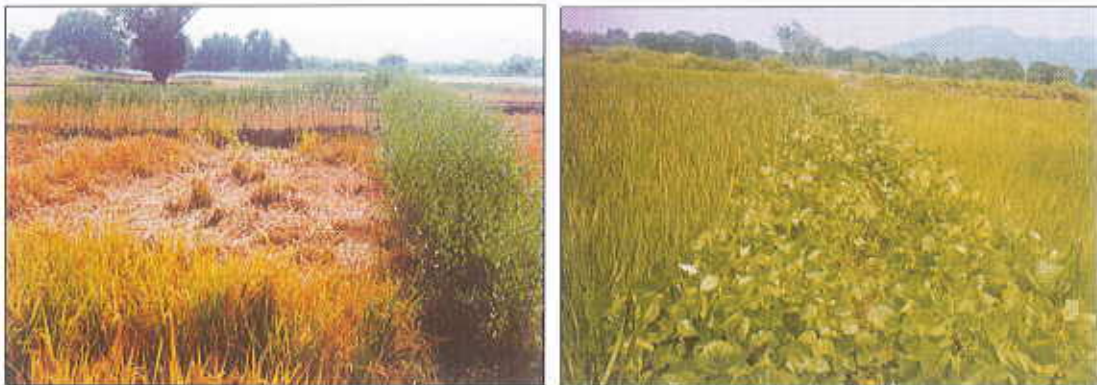
Plate 19. Arhar grown on the bund of paddy field. Plate 20. Black gram grown on the bunds of paddy field.

From soil conservation point of view as well as from bund stability point of view, it was advised to keep the bund under some crop. Black gram as well as arhar was recommended to be grown on the bund. The picture is shown in plate 19 and plate 20.
